SPRINKLER SYSTEM

PELICAN STATE INSPECTION, L.L.C.

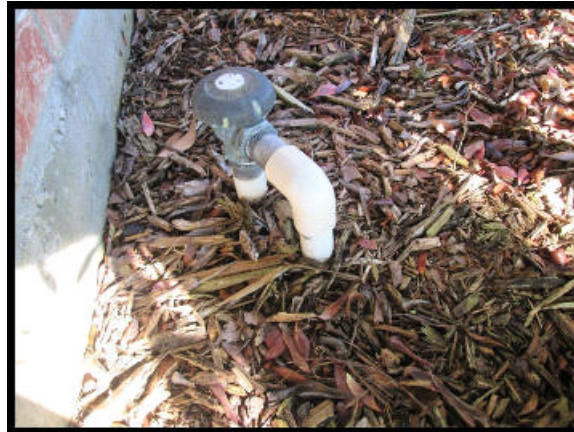
BACKFLOW PREVENTER

There was backflow preventer device installed for the lawn sprinkler system. It was installed at the front of the house.

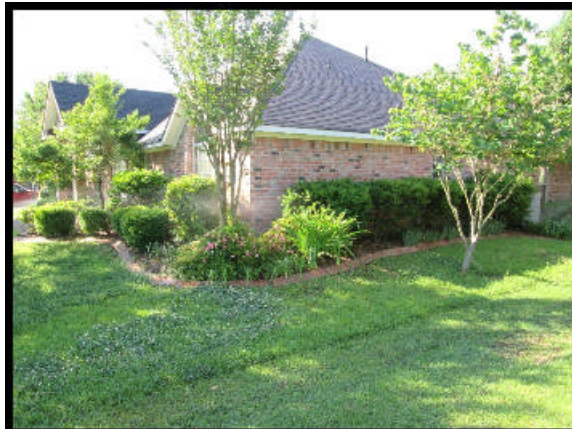
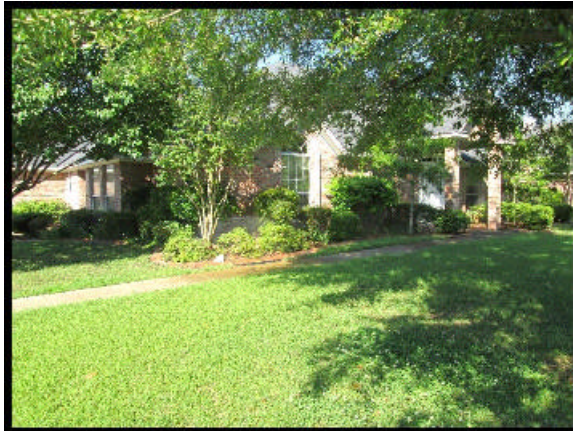
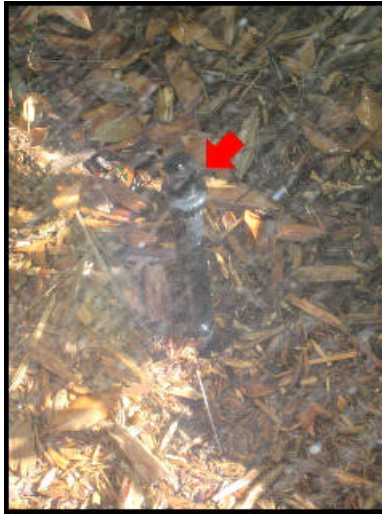
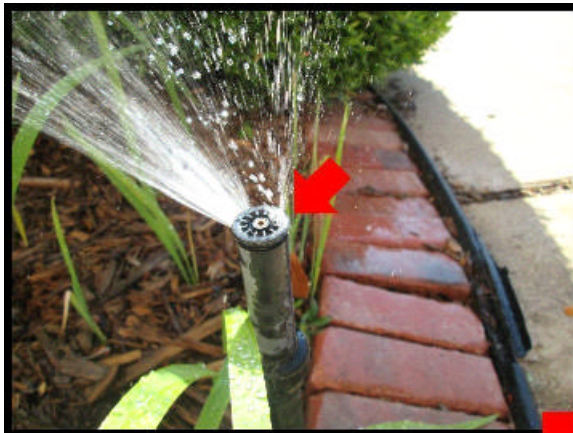
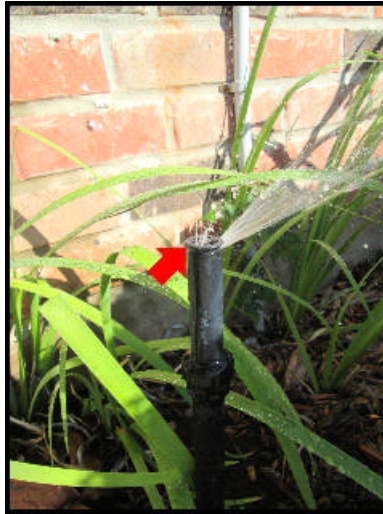
ZONE #1

There was a head on the left of the house by the side entry door that did not function.
There were also 2 damaged spray heads noted in this zone.

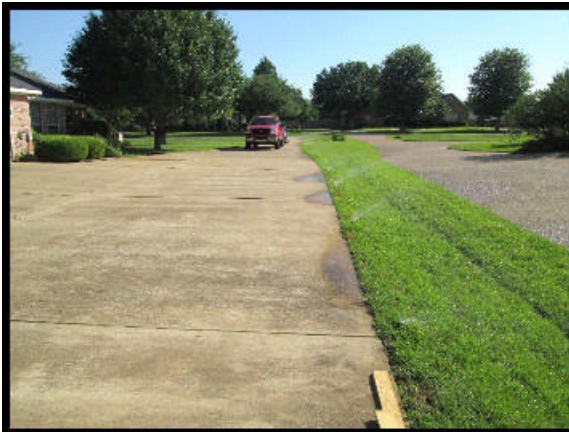
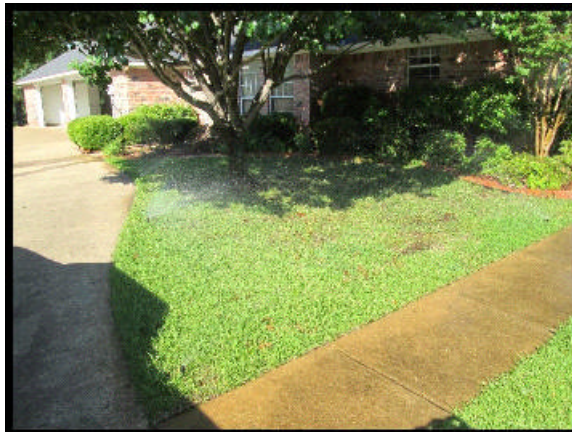
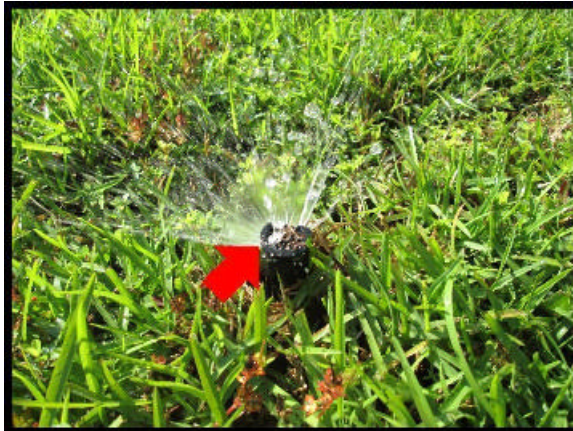
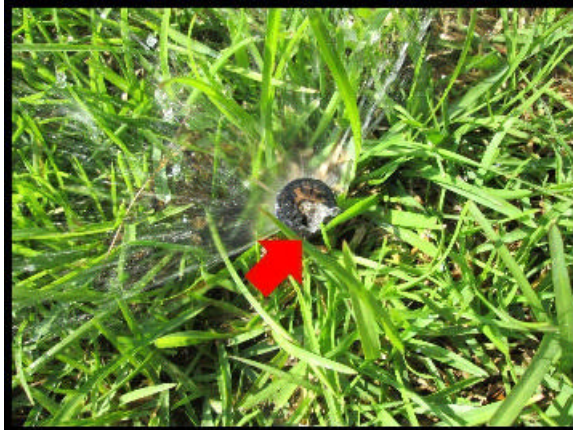
ZONE #2

There were 2 damaged spray heads noted in this zone.

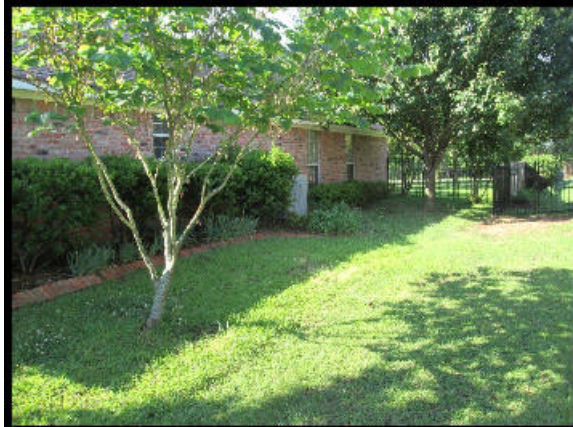
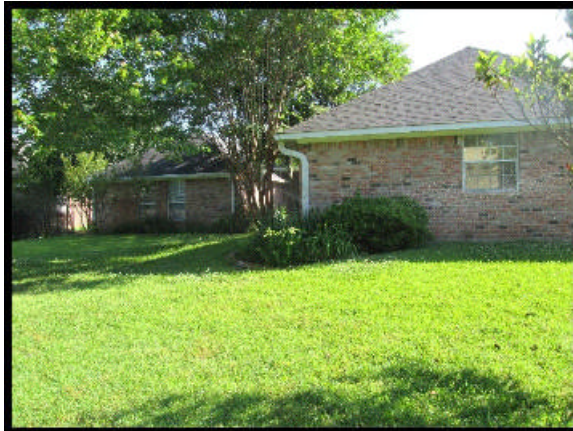
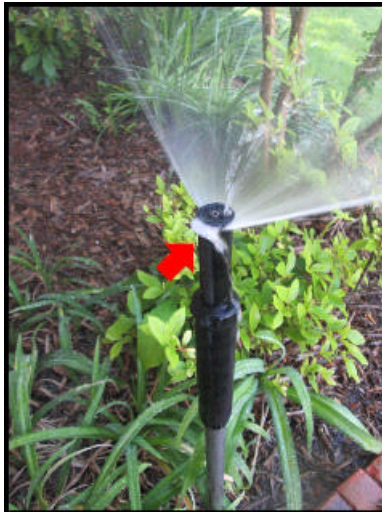
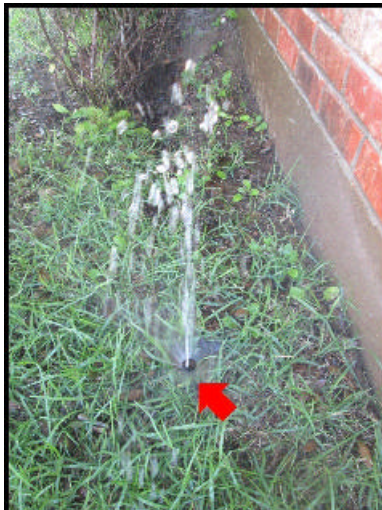
ZONE #3

There were 2 damaged heads in this zone.

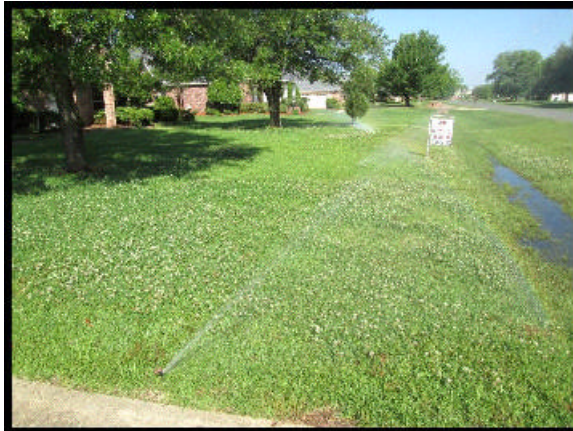
ZONE #4

The rotary spray heads in this zone were functional.

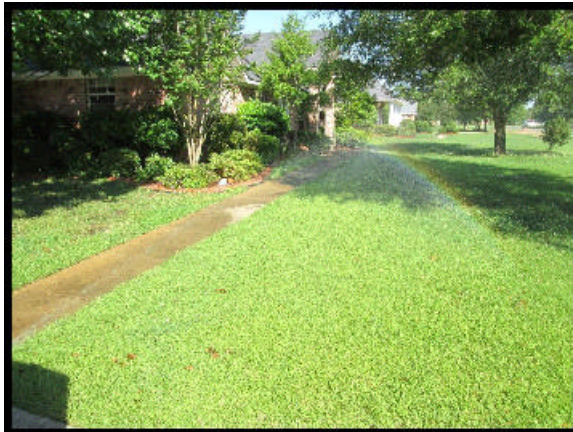
ZONE #5

The rotary spray heads in this zone were functional.

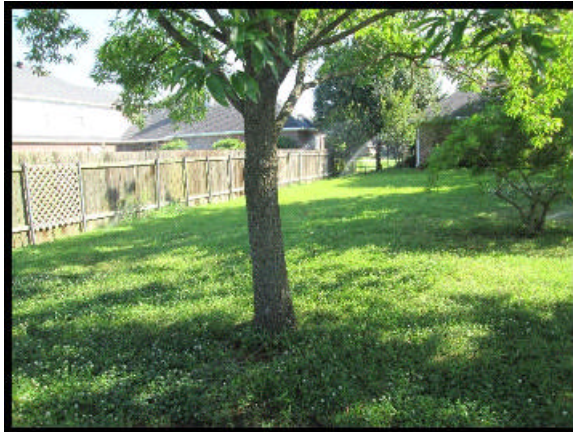
ZONE #6

The rotary spray heads in this zone were functional.

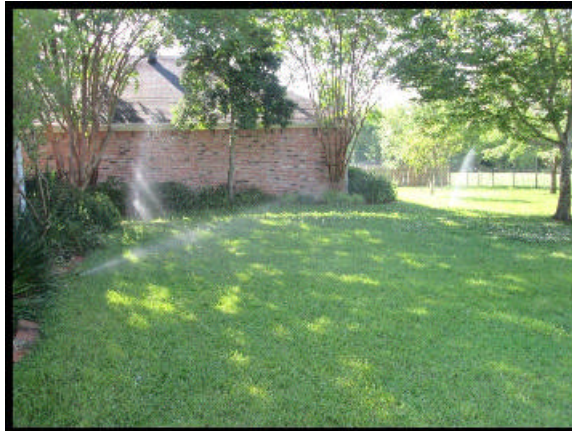
ZONE #7

The rotary spray heads in this zone were functional.

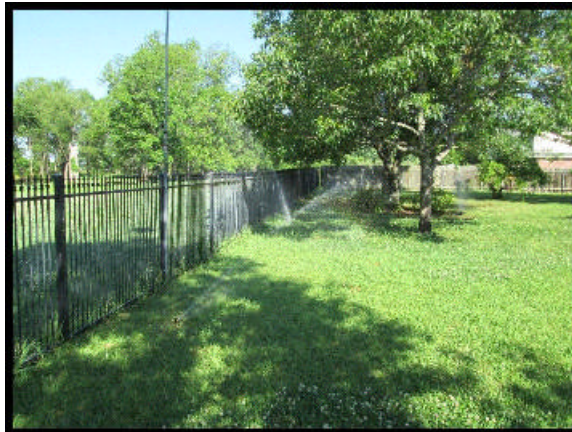
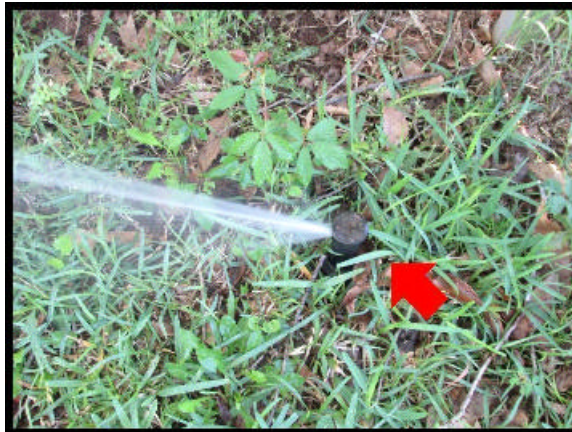
ZONE #8

There was a rotary head in this zone that did not rotate.
